David Salenius
Original Stone
Auckland

BTS1921 - CERTIFICATE OF TEST: TR190514-1

WEATHERTIGHTNESS TEST OF A SAMPLE WALL

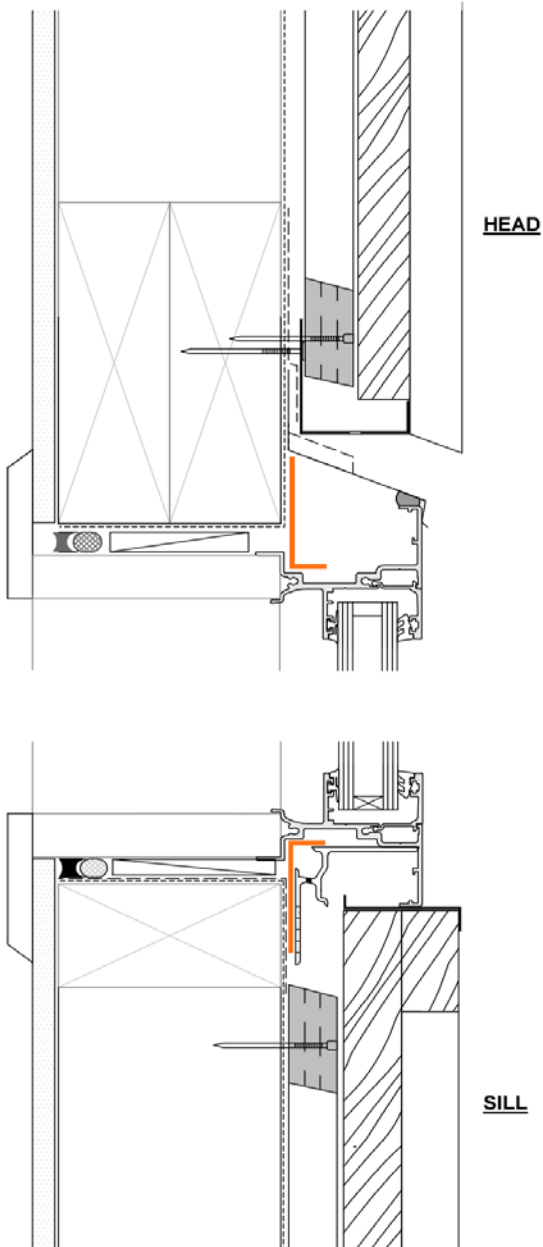
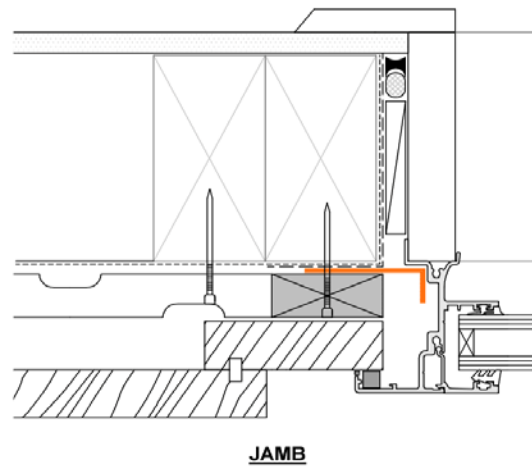
Drawings 1 -3 – Drawings showing the application of tapes as part of a “frame protection system”

- 5.02 The wall sample incorporated a "frame protection system" over the timber framing. i.e. all perimeter and overlapping edges of the underlay were taped with a vapour permeable waterproof tape. The gap between the underlay and the aluminium window frame was made both air-tight and waterproof by way of use of vapour permeable and waterproof tape, with split liner on the back, to enable one section of the length of the tape to be applied to the window frame, before the remaining section was applied to the surrounding underlay. Refer to the attached drawings.

Drawings 1 -3 – Drawings showing the application of tapes as part of a “frame protection system”

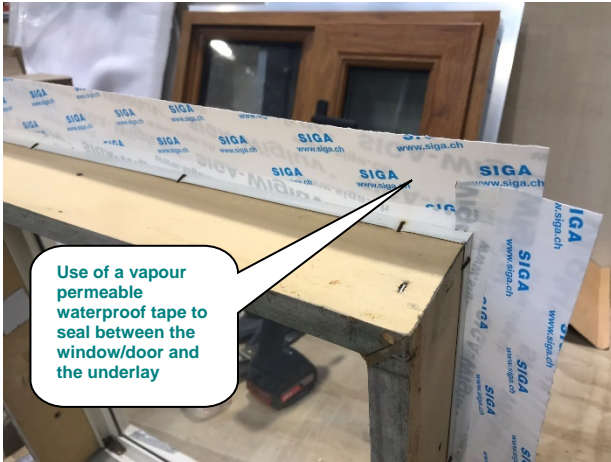
Figure 1. Sample window with tape.

Figure 1. Sample window with tape.

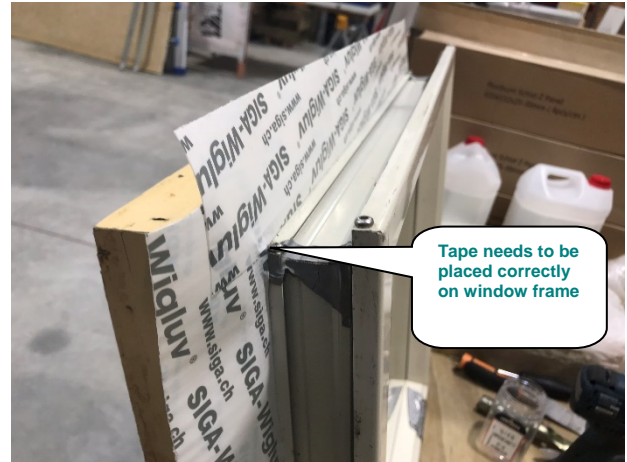
Figure 2. Sample window with tape.

Figure 2. Sample window with tape.

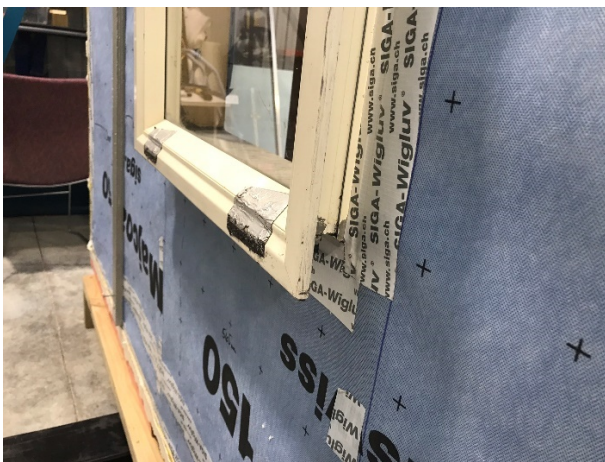
Figure 3. Sample window taped to underlay system.

Figure 3. Sample window taped to underlay system.

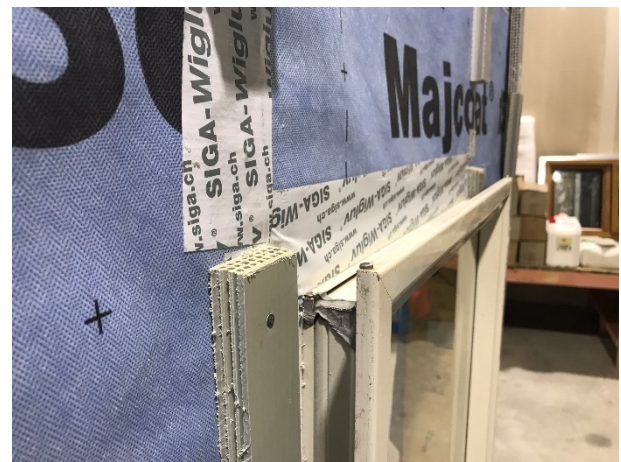
Figure 4. Sample window taped to underlay system.

Figure 4. Sample window taped to underlay system.

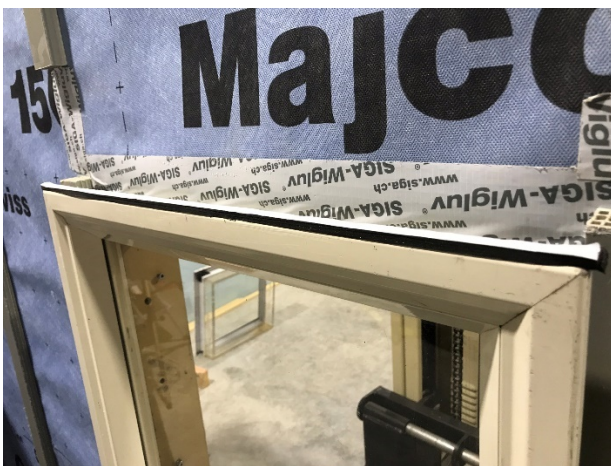
Figure 5. Application of foam tape on top of window.

Figure 5. Application of foam tape on top of window.

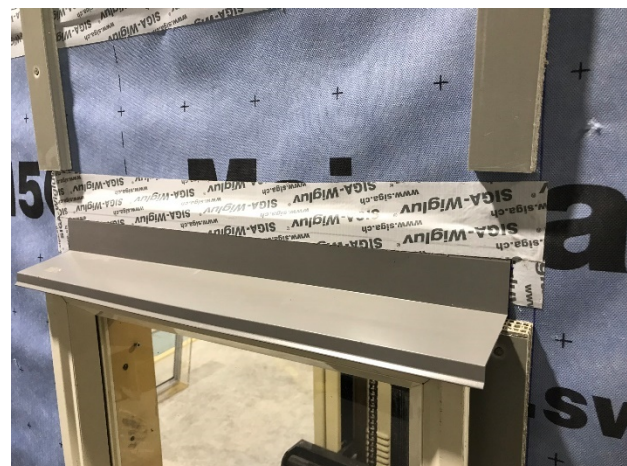
Figure 6. Window Head Flashing installed.

Figure 6. Window Head Flashing installed.

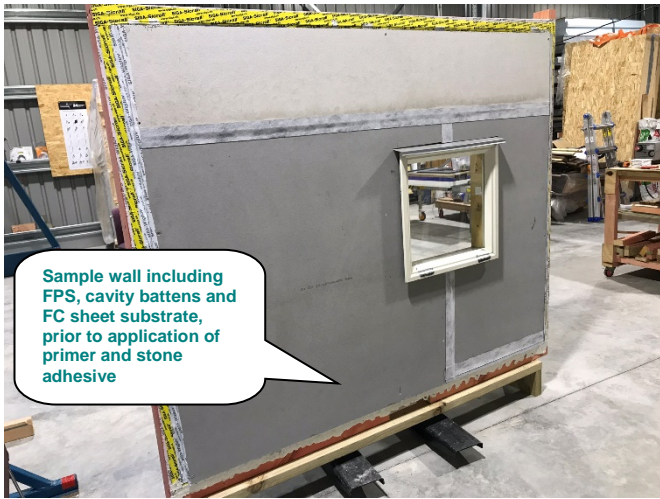
Figure 7. Sample wall ready for application of stone.

Figure 7. Sample wall ready for application of stone.

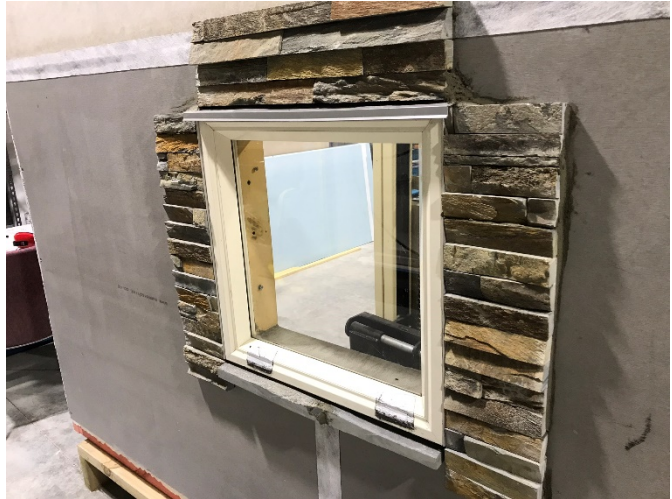
Figure 8. Representative stone installed around the window.

Figure 8. Representative stone installed around the window.

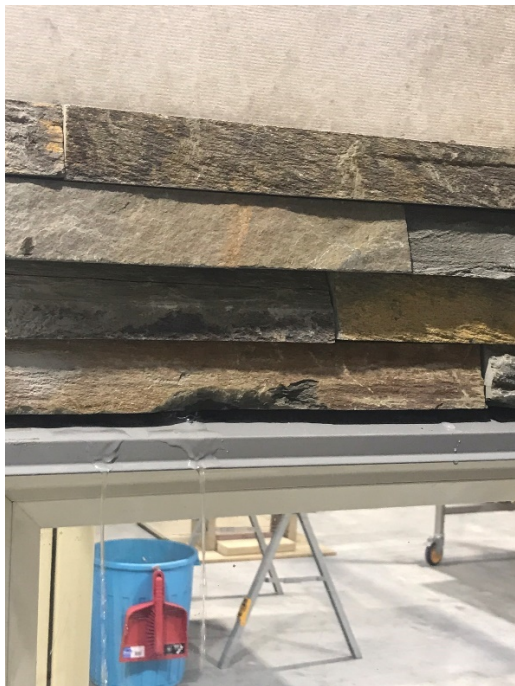
Figure 9. Water management test above the window head flashing.

- 2.05 Water Management Test of the window head flashing. Water was poured into the upper part of the cavity directly above the window head flashing to assess the water management of this.

Figure 9. Water management test above the window head flashing.
